RS Service Bulletin

SB 19-01 R2

BRS 901 and 601 Igniter Rocket Base Inspection

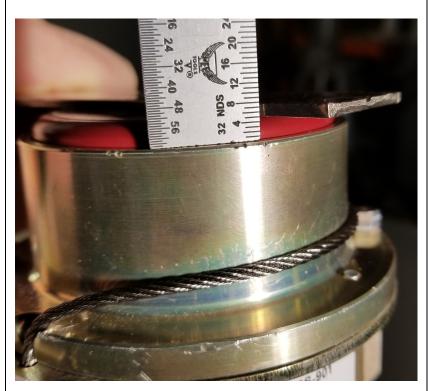
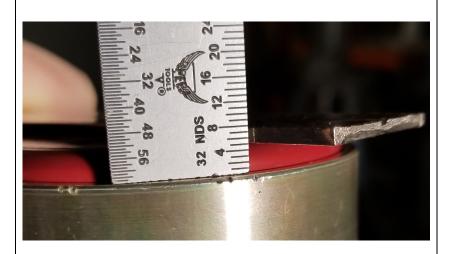
Rocket Protrusion

Some airplanes may exhibit a condition where upon further inspection the BRS rocket motor may not be fully seated or retained. This service Bulletin will explain how to inspect for the presence of this condition.

- 1.6. Lay a flat edge over the top of the motor case. With a 32nds" measuring ruler, confirm that the rocket motor case does not protrude past the top edge of the pickup collar more than 5/32".
- 1.7. If your measurement is outside of the tolerance, please immediately contact BRS Aerospace with your results.
- 1.8. If you are within tolerance, move on to step 1.9

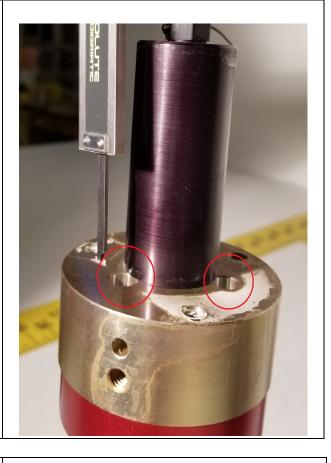
Nylon Screw Depth Check

1.9. Locate the 3 holes in the bottom of the rocket base, where the nylon retention screws are located
